Debris examination – update No. 3

Missing aircraft, Boeing 777, 9M-MRO, 8 March 2014

**Identification of large flap section
recovered off the Tanzanian coast**

AE-2014-054

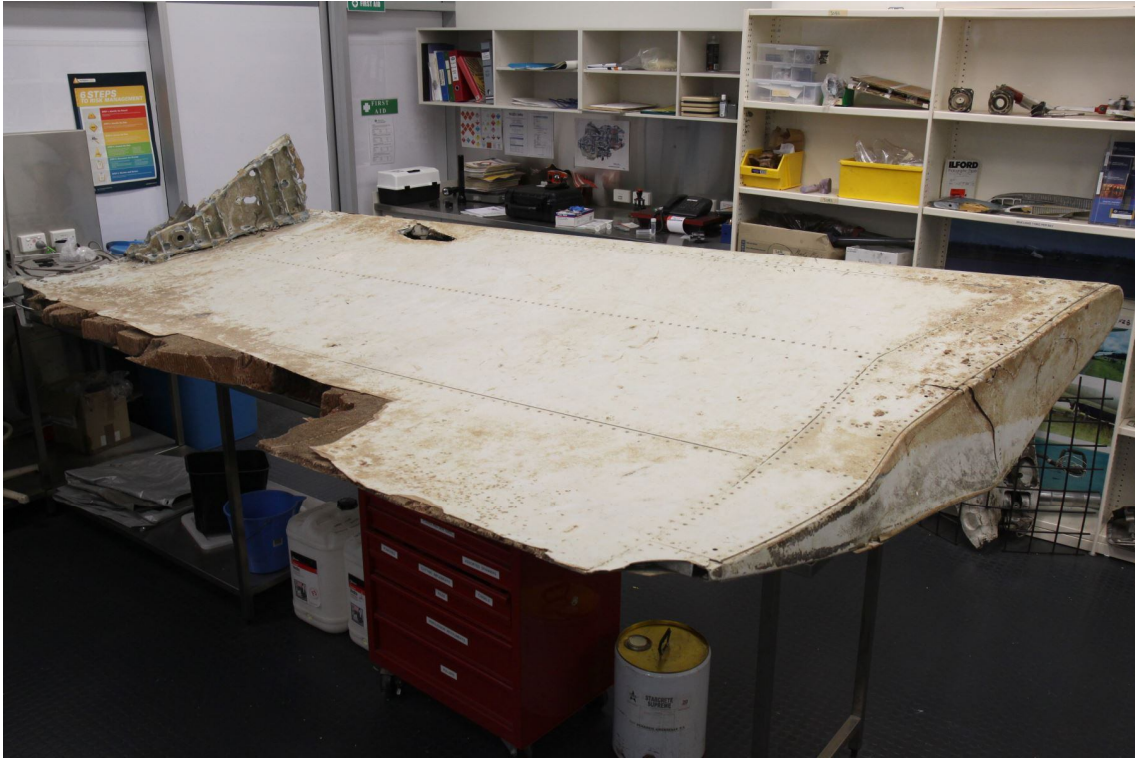
Part number 5 was preliminarily identified from photographs as an inboard section of a Boeing 777 outboard flap. On arrival at the ATSB, several part numbers were immediately located on the debris that confirmed the preliminary identification. This was consistent with the physical appearance, dimensions and construction of the part.

Figure 1: Inboard section of outboard flap (inverted)

On 20 June 2016, a large item of debris was found on the island of Pemba, off the coast of Tanzania. Preliminary identification from photographs indicated that the item was likely a section of Boeing 777 outboard flap (Figure 1).

It was confirmed that Part No. 5 was the inboard section of a Boeing 777 right, outboard flap, originating from the Malaysian Airlines aircraft registered 9M-MRO.

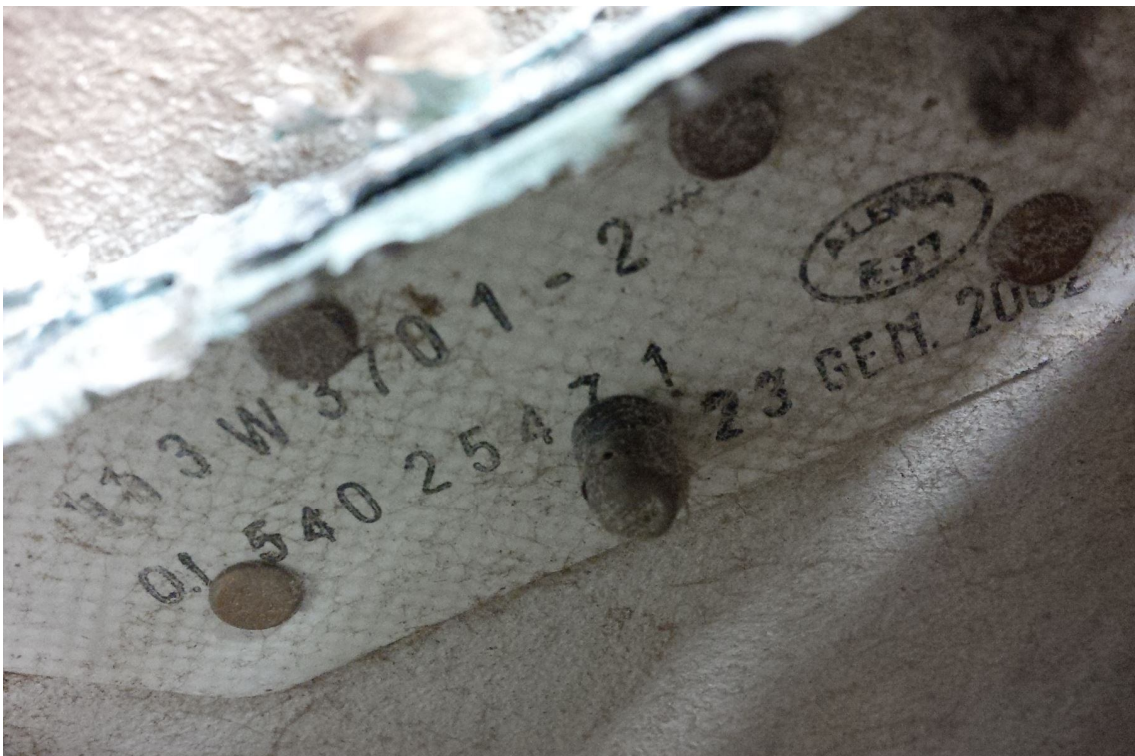
A date stamp associated with one of the part numbers indicated manufacture on 23 January 2002 (Figure 2), which was consistent with the 31 May 2002 delivery date for 9M-MRO.

Figure 2: Exemplar part number and date stamp

All of the identification stamps had a second “OL” number, in addition to the Boeing part number, that were unique identifiers relating to part construction. The Italian part manufacturer recovered build records for the numbers located on the part and confirmed that all of the numbers related to the same serial number outboard flap that was shipped to Boeing as line number 404. Aircraft line number 404 was delivered to Malaysian Airlines and registered as 9M-MRO.
